STATE OF CALIFORNIA  
DEPARTMENT OF FISH AND WILDLIFE

### Notice of Violation of Fish and Game Code Sections 1602 and 3503

**Attachment A: Photographs**

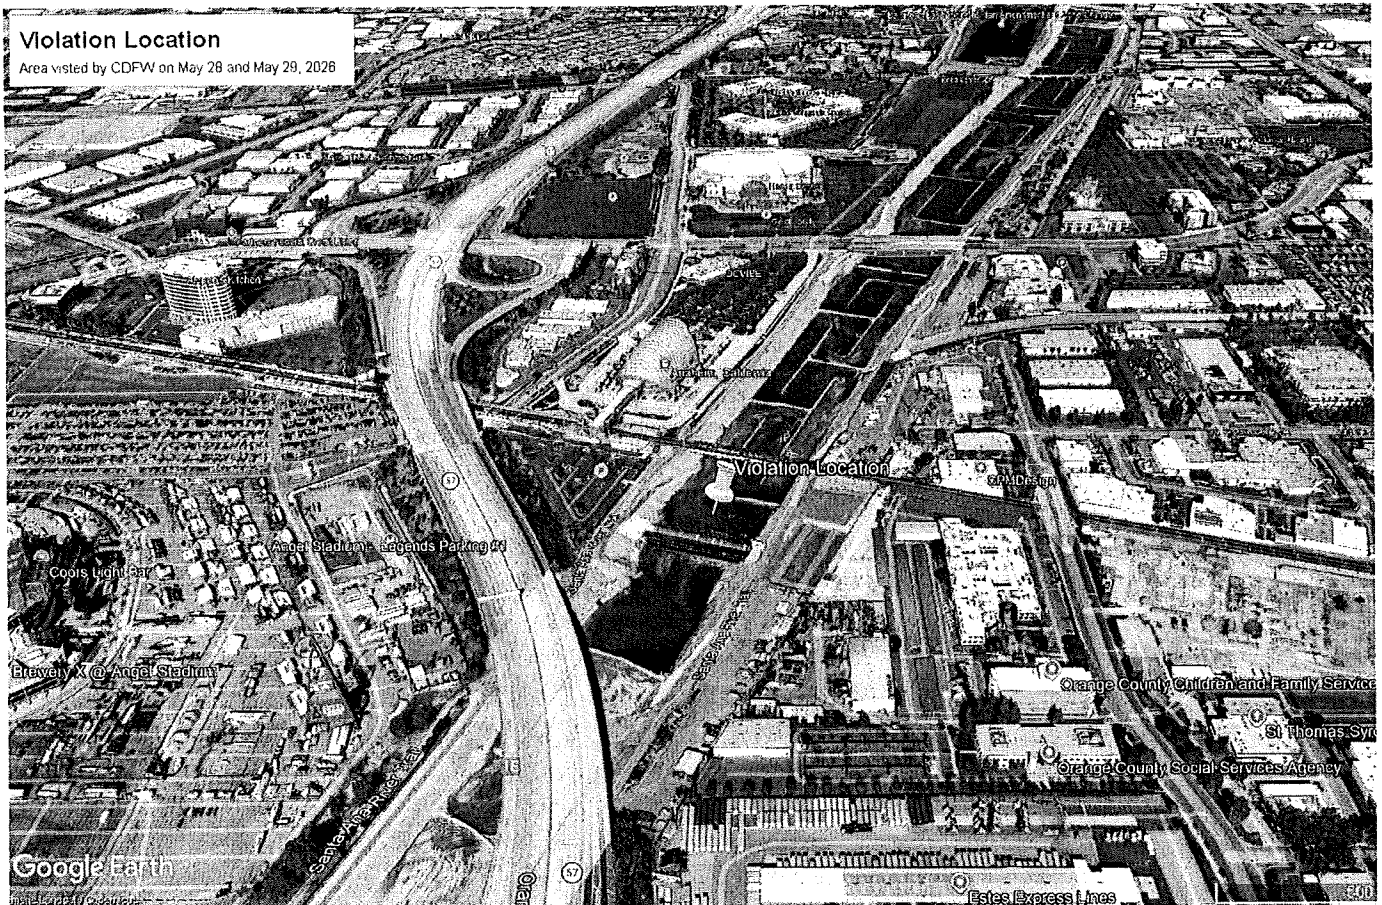
Photo 1: Area map which shows the general location where the violations occurred in the Santa Ana River. The location is bounded by the railroad bridge to the north, Interstate 57 to the south, North Eckhoff Street to the east, and an Amtrak parking lot to the west.

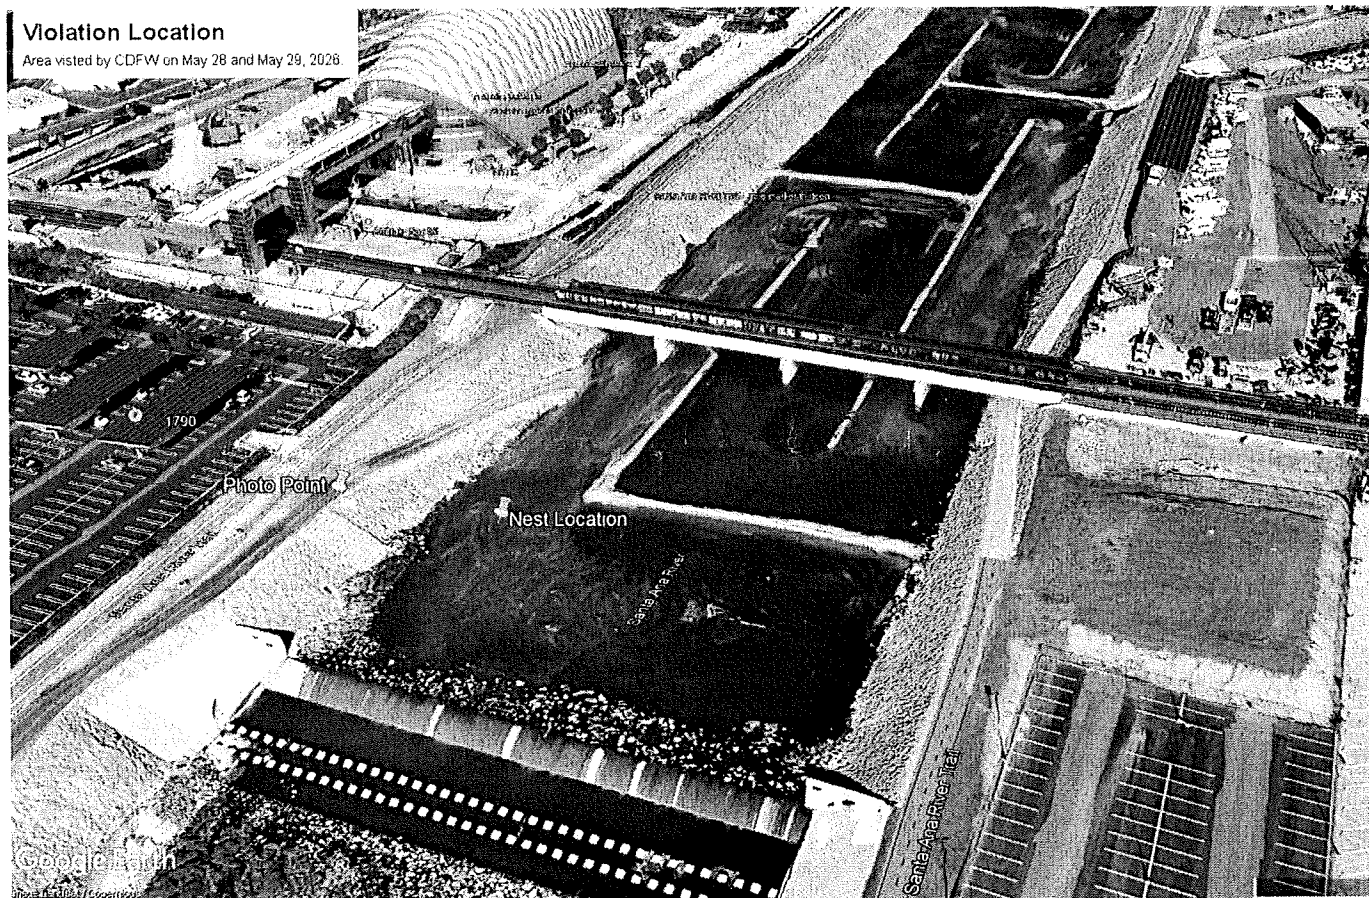
Photo 2: Location of where the violations occurred, including photo point by Lt. Nicholas Molsberry and the approximate location of the destroyed nest (33.801160°N, 117.87706°W).

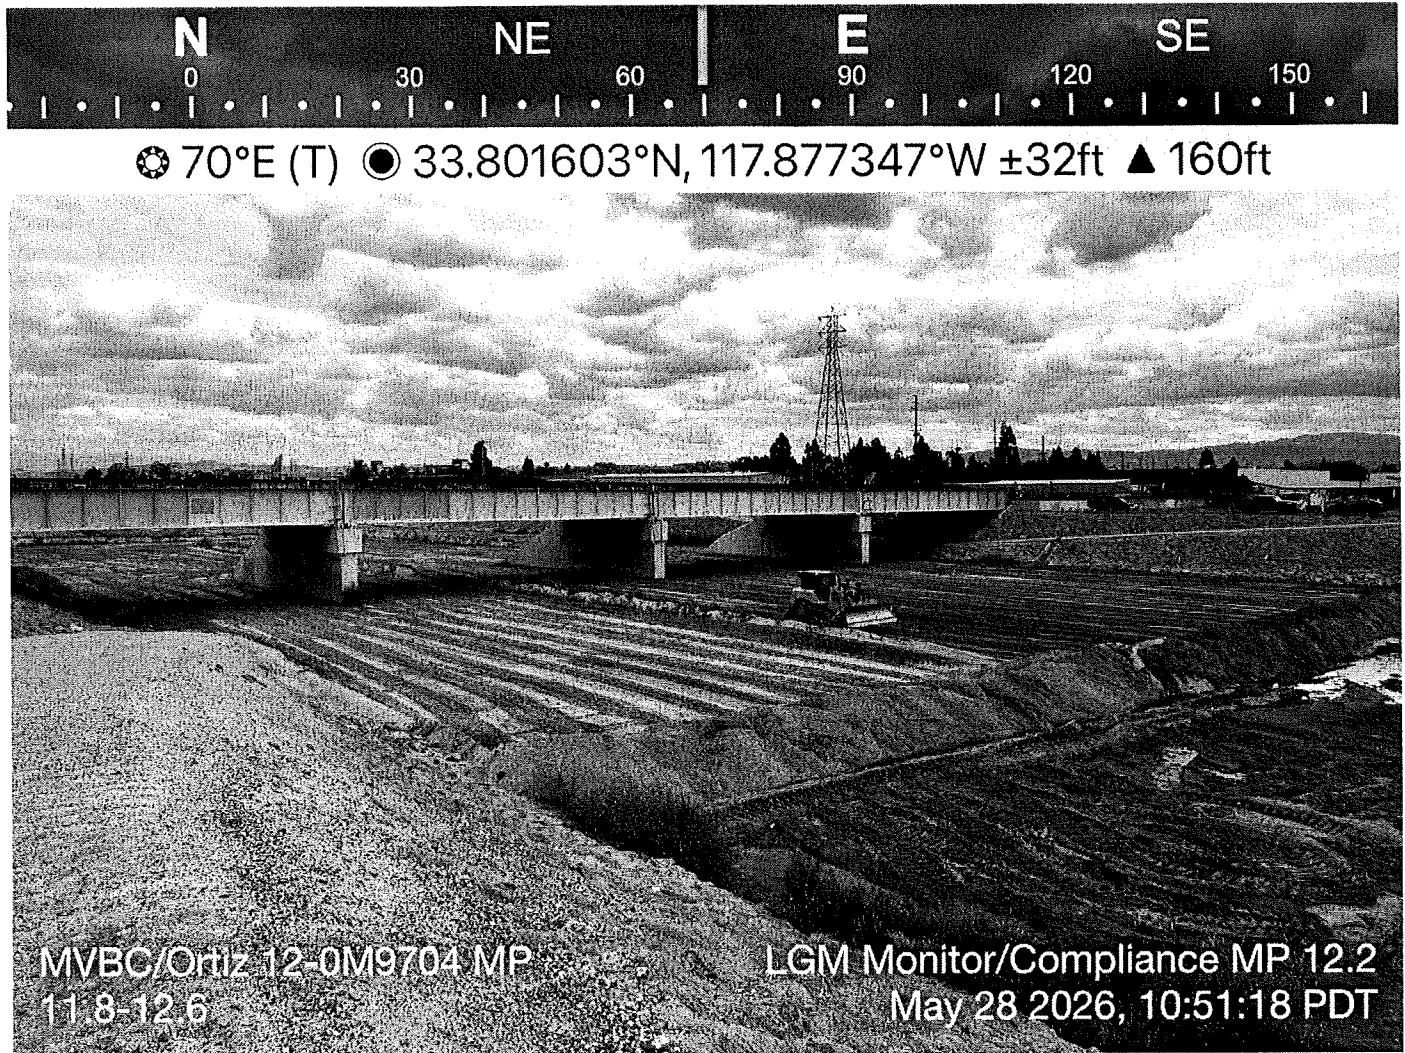
- 1.5. Notification Prior to Work. CDFW did not receive notification five days prior to activities occurring in the Santa Ana River, as this condition requires. (See Attachment A, Photos 1-3.)

Photo 3: Santa Ana River Reach 4 between the Amtrak rail bridge to the north and Interstate 57 to the south. Photo taken on May 28, 2026, by Lt. Nicholas Molsberry.

To address these violations and avoid similar violations in the future, OCWD needs to ensure that all OCWD employees and contractors who conduct work under the Agreement fully understand and fully comply with all conditions therein, especially condition 1.5, to avoid harm to birds and other fish and wildlife resources the Santa Ana River supports. In addition, OCWD will need to mitigate for the nest destruction. Please contact Jennifer Turner at (858) 539-9109 or by email at [jennifer.turner@wildlife.ca.gov](mailto:jennifer.turner@wildlife.ca.gov) as soon as possible to arrange a meeting between OCWD and CDFW to resolve this matter.

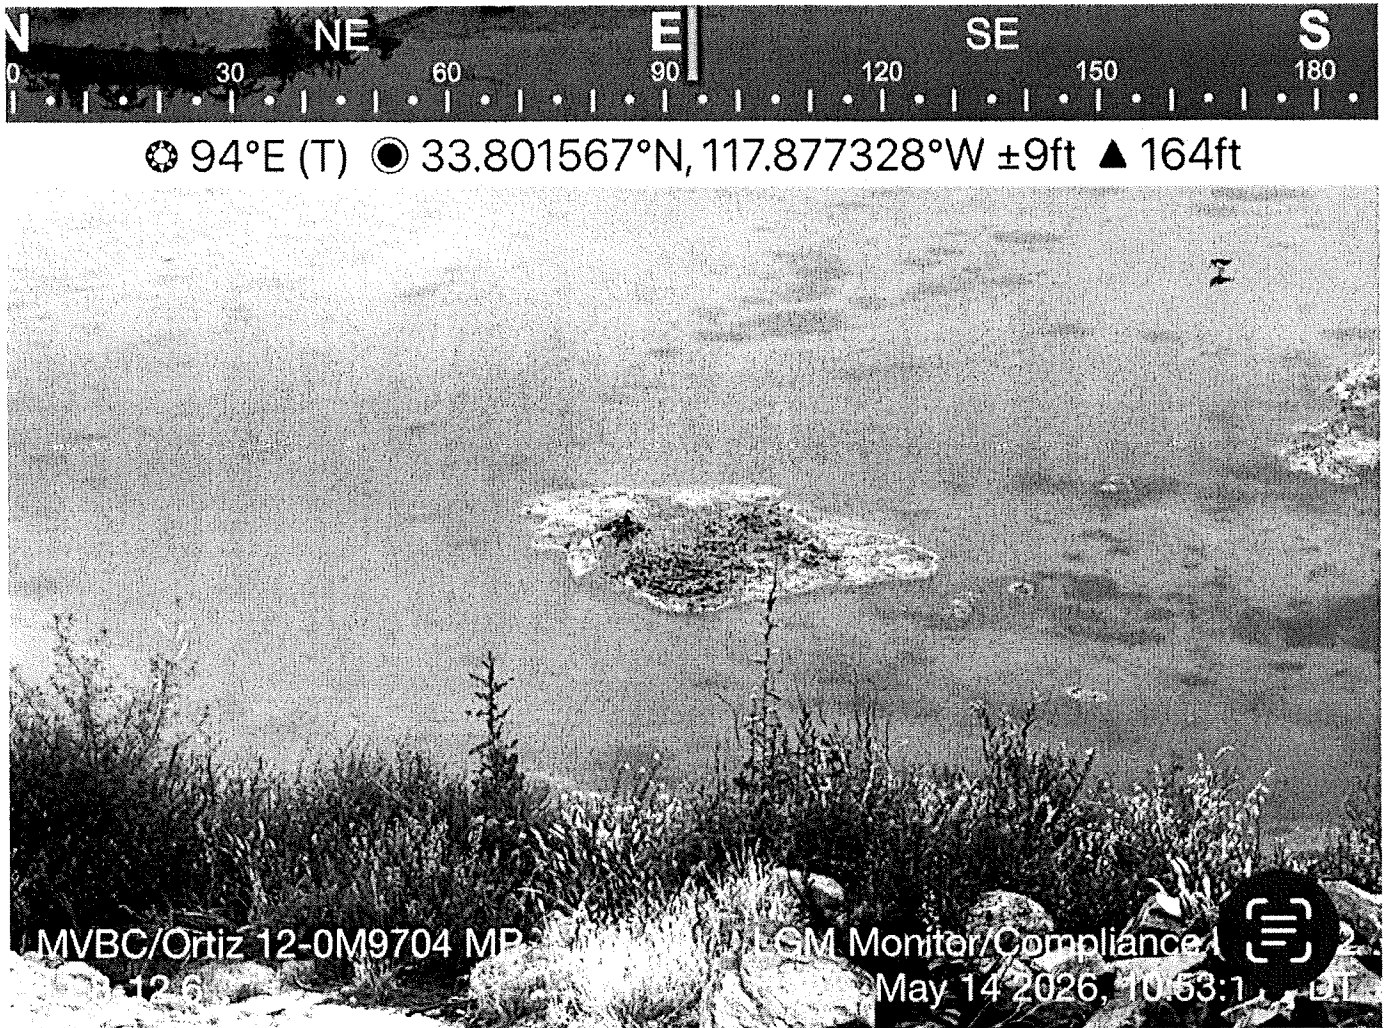
Photo 4: Black-necked stilt nest. Photo taken on May 14, 2026, by Laura Muhlhauser, the reporting party.

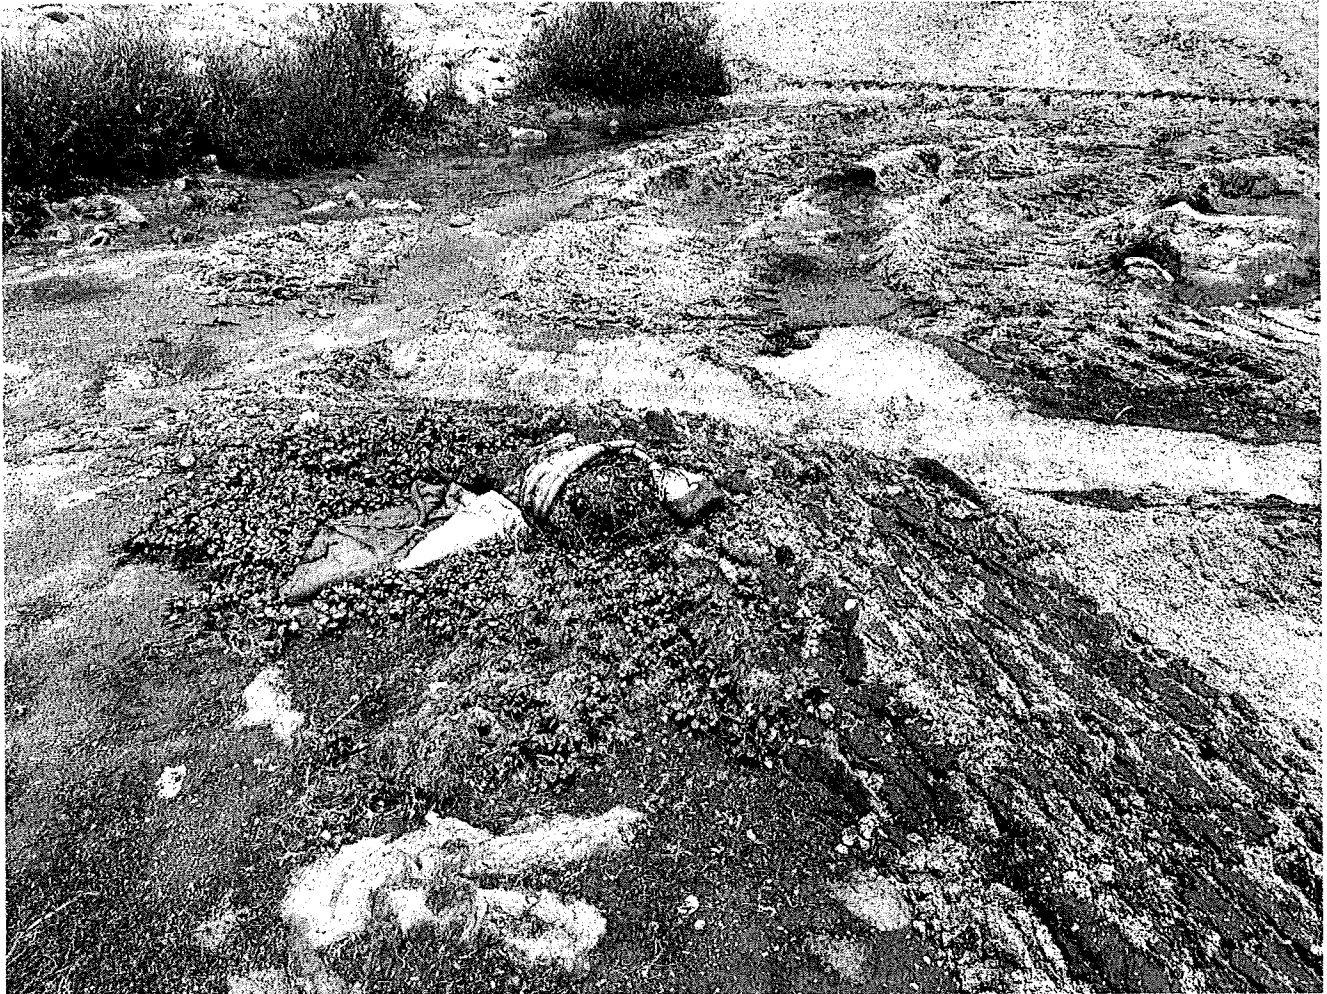
- 2.8. Nesting Bird Avoidance and Protection. OCWD nesting survey data substantiate that nesting surveys occurred. However, there was no physical delineation of nesting bird buffers observed within the work area, as this condition requires. In addition, maintenance activities occurred within 300 feet of known active nests, which this condition prohibits.

Photo 5: Location of the black-necked stilt nest, post bulldozer disturbance. Photo taken on May 28, 2026, by Lt. Nicholas Molsberry.
